OFFICIAL ALABAMA WOOD INFESTATION INSPECTION REPORT --- Part A

Company Name ABC Pest Group **License No.** 1234567890
Address PO Box 2831 Montgomery, AL 36107
Telephone No. (999) 555-0000 **Date of Inspection** July 17, 2007 **Date of Issuance** July 17, 2007
Seller Rusty Jordan **Purchaser(s)** Rusty Jordan **Inspector** Sam Eagleye

- Main Structure House Other Structures (Specify) Garage, shed.
 Address of Structure 9830 Cornell Avenue Montgomery, AL 46280
- It appears that the structure(s) or a portion thereof may have been previously treated.
 Evidence of previous treatment: _____
 This company can give no assurances with regard to work that may have been previously performed by other companies.
 The company, which treated the property, should be contacted by the Buyer for treatment and contract information.

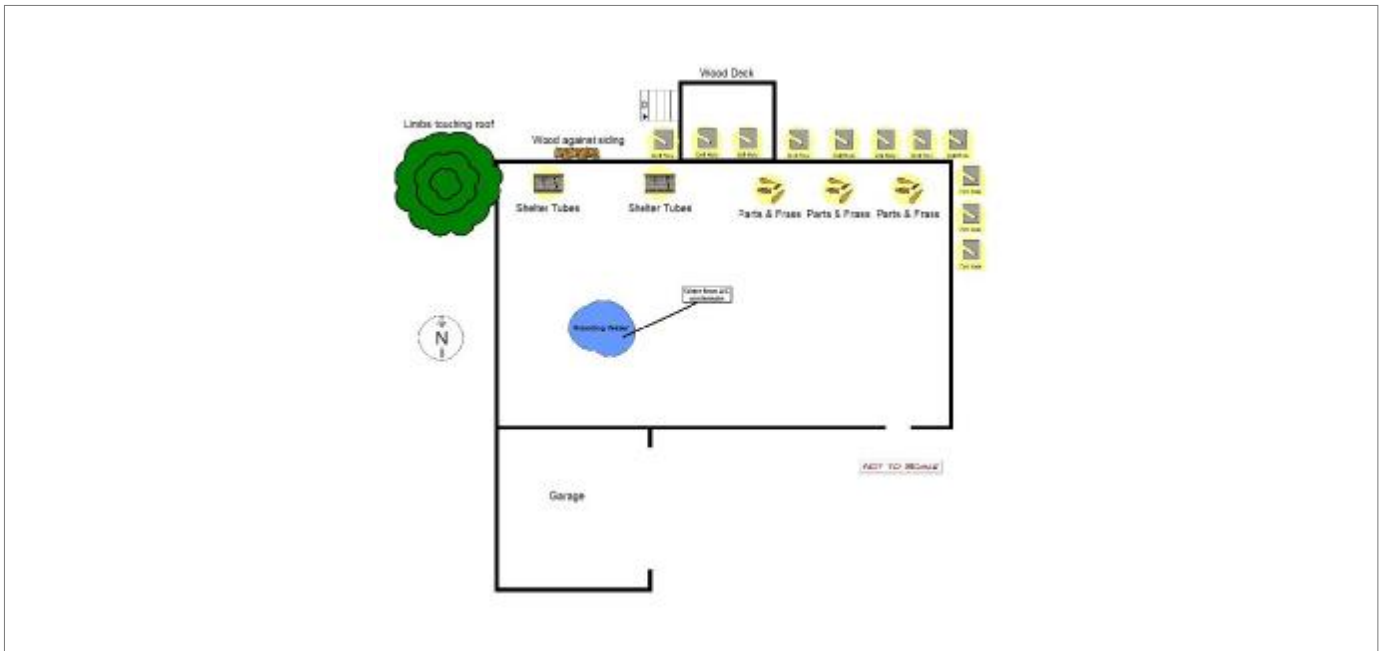
DIAGRAM

ACTIVE	PREVIOUS	
<input checked="" type="checkbox"/>	<input type="checkbox"/>	SUBTERRANEAN TERMITES Live Subterranean Termites located along east wall of crawl
<input type="checkbox"/>	<input type="checkbox"/>	POWDER POST BEETLES
<input type="checkbox"/>	<input type="checkbox"/>	WOOD BORING BEETLE
<input type="checkbox"/>	<input type="checkbox"/>	DRY WOOD TERMITES
<input type="checkbox"/>	<input type="checkbox"/>	WOOD DECAYING FUNGI
